FLOOD PLAIN MANAGEMENT STUDY

KAYENTA COMMUNITY

Navajo County, Arizona

DECEMBER 1988

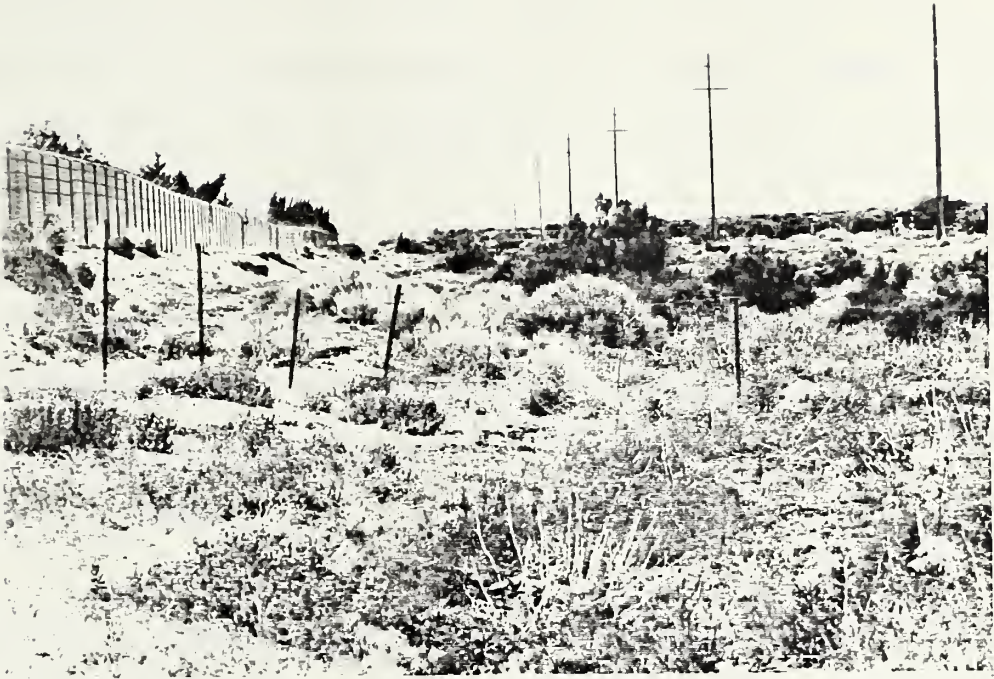
Figure 3
Kayenta Public School Complex Flood Dike & Channel

The major work done to protect developments in Kayenta was the installation of an earth channel and dike along the southern edge of the Kayenta Public School complex (Monument Valley High School). This system has functioned well to protect this area. (See photo, Figure 3.)

Kayenta Public School Complex—When this school complex was constructed a dike and flood channel was installed along the major length of the southern (upstream) edge of the complex. (Refer to photo, Figure 3.) The system was sized such to satisfactorily control what has been determined in this study as the 100-year peak flow. At the head and upstream of this system an older dike (predating 1970) intercepts floodwater and diverts it into this dike/channel system. This study shows that the older dike will be overtopped by the 100-year flood and that it is in a weakened condition that probably will fail by the action of smaller, more frequent floods. Overtopping and/or breaching of this older dike will cause flood damage to the Kayenta Public School Complex

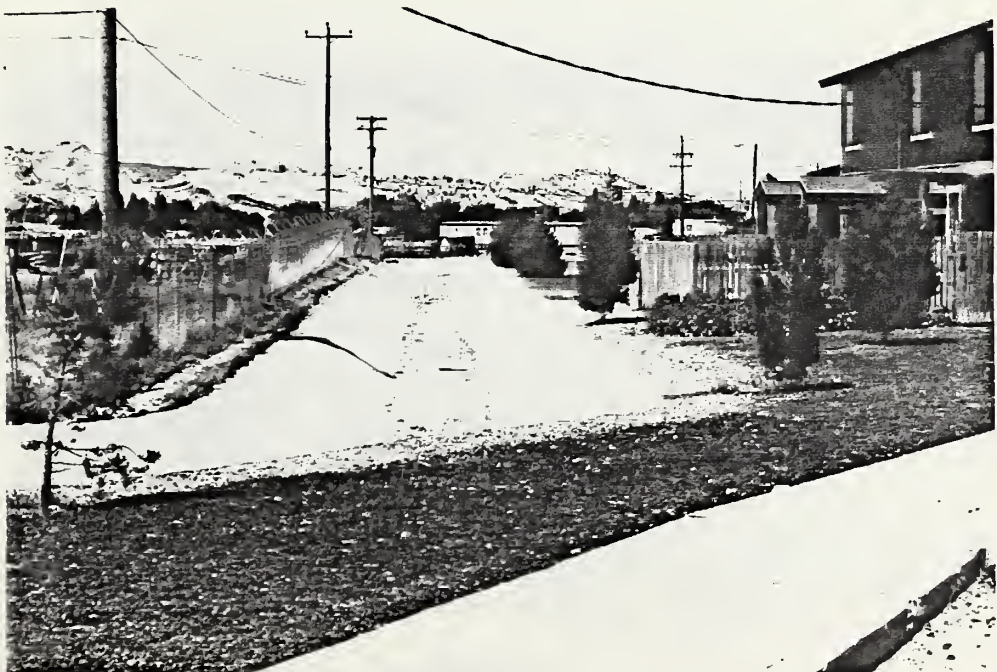
Figure 4
Kayenta Public School Complex Concrete Flood Channel

A concrete lined channel was also constructed on the southwest edge of the Kayenta Public School complex to intercept local runoff and convey it around to the east edge of the complex. (Refer to photo, Figure 4.)

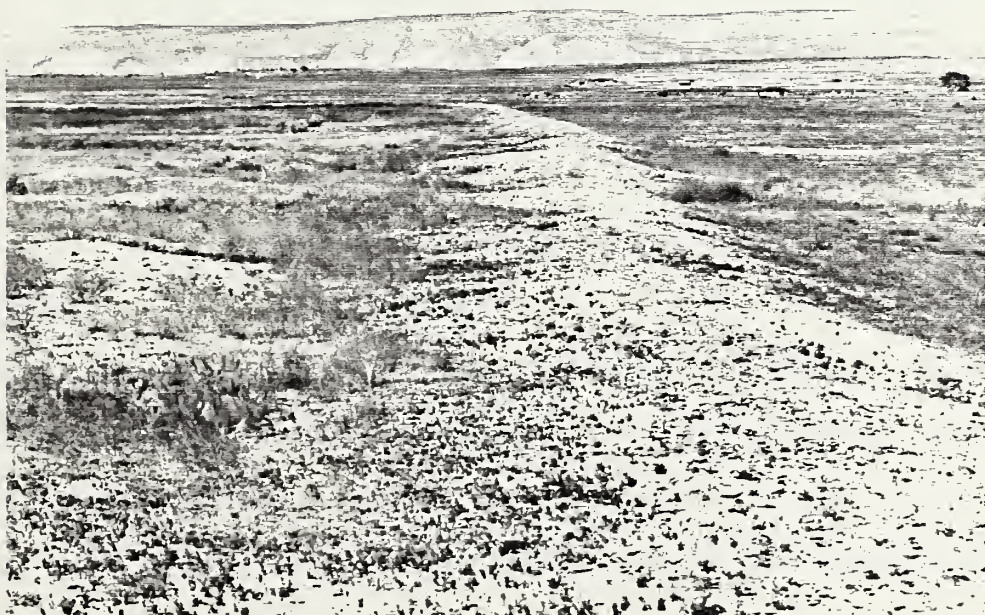
Figure 5
Dike Installed for Diversion and Spreading Surface Flows

Low dikes have been installed in at least two locations to divert and spread excess water to increase forage for grazing. One dike is located about 3,000 feet to the northwest of the intersection of Highways 160 and 163 and the other is about one mile to the northeast of the highway intersection. These diversion dikes have been silted in and badly eroded to the point where they have little effect. (See photo, Figure 5.)

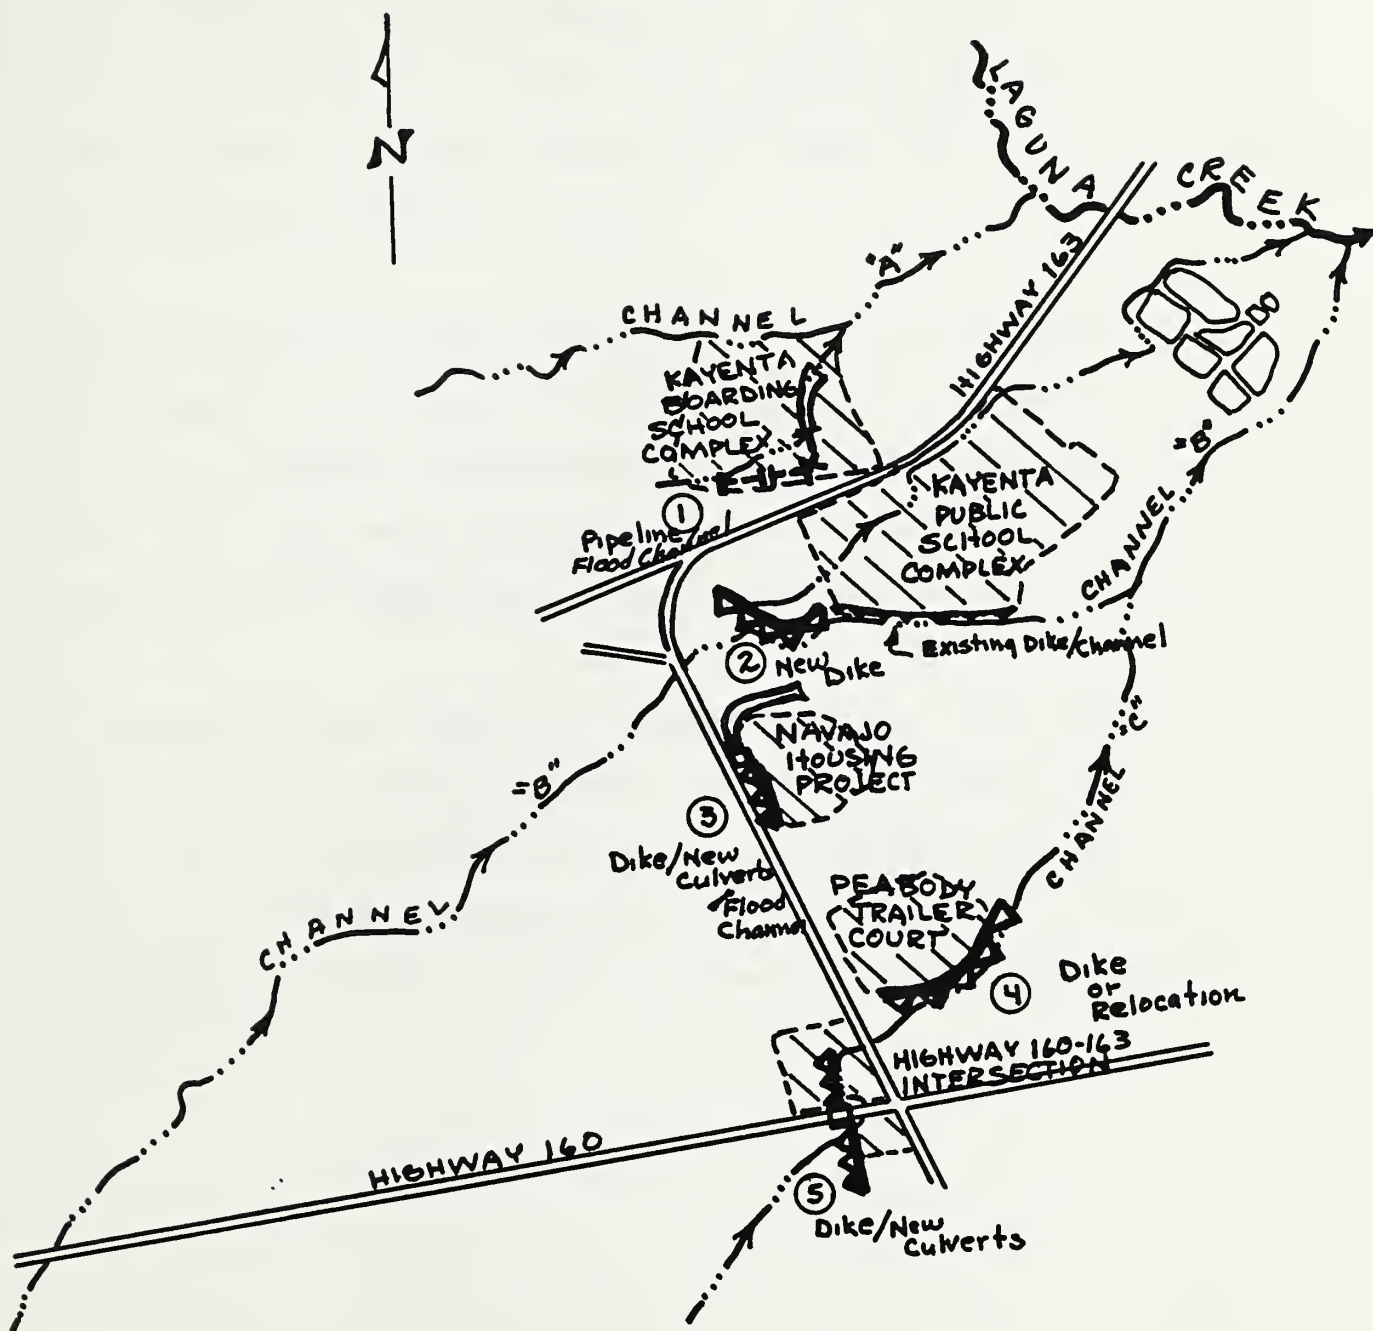
Figure 6
Structural Alternatives Considered

the most effective control. In this study a more comprehensive system considered the installation of several structural components at five locations where significant damage can be expected. These five areas include (1) the Kayenta Boarding School, (2) the Kayenta Public School Complex, (3) the Navajo Housing Project, (4) the Peabody Trailer Court and (5) the intersection area of Highways 160 and 163. Refer to the map, Figure 6. At each location the evaluation was based upon controlling the 100-year flood. Following is a brief explanation of the findings.

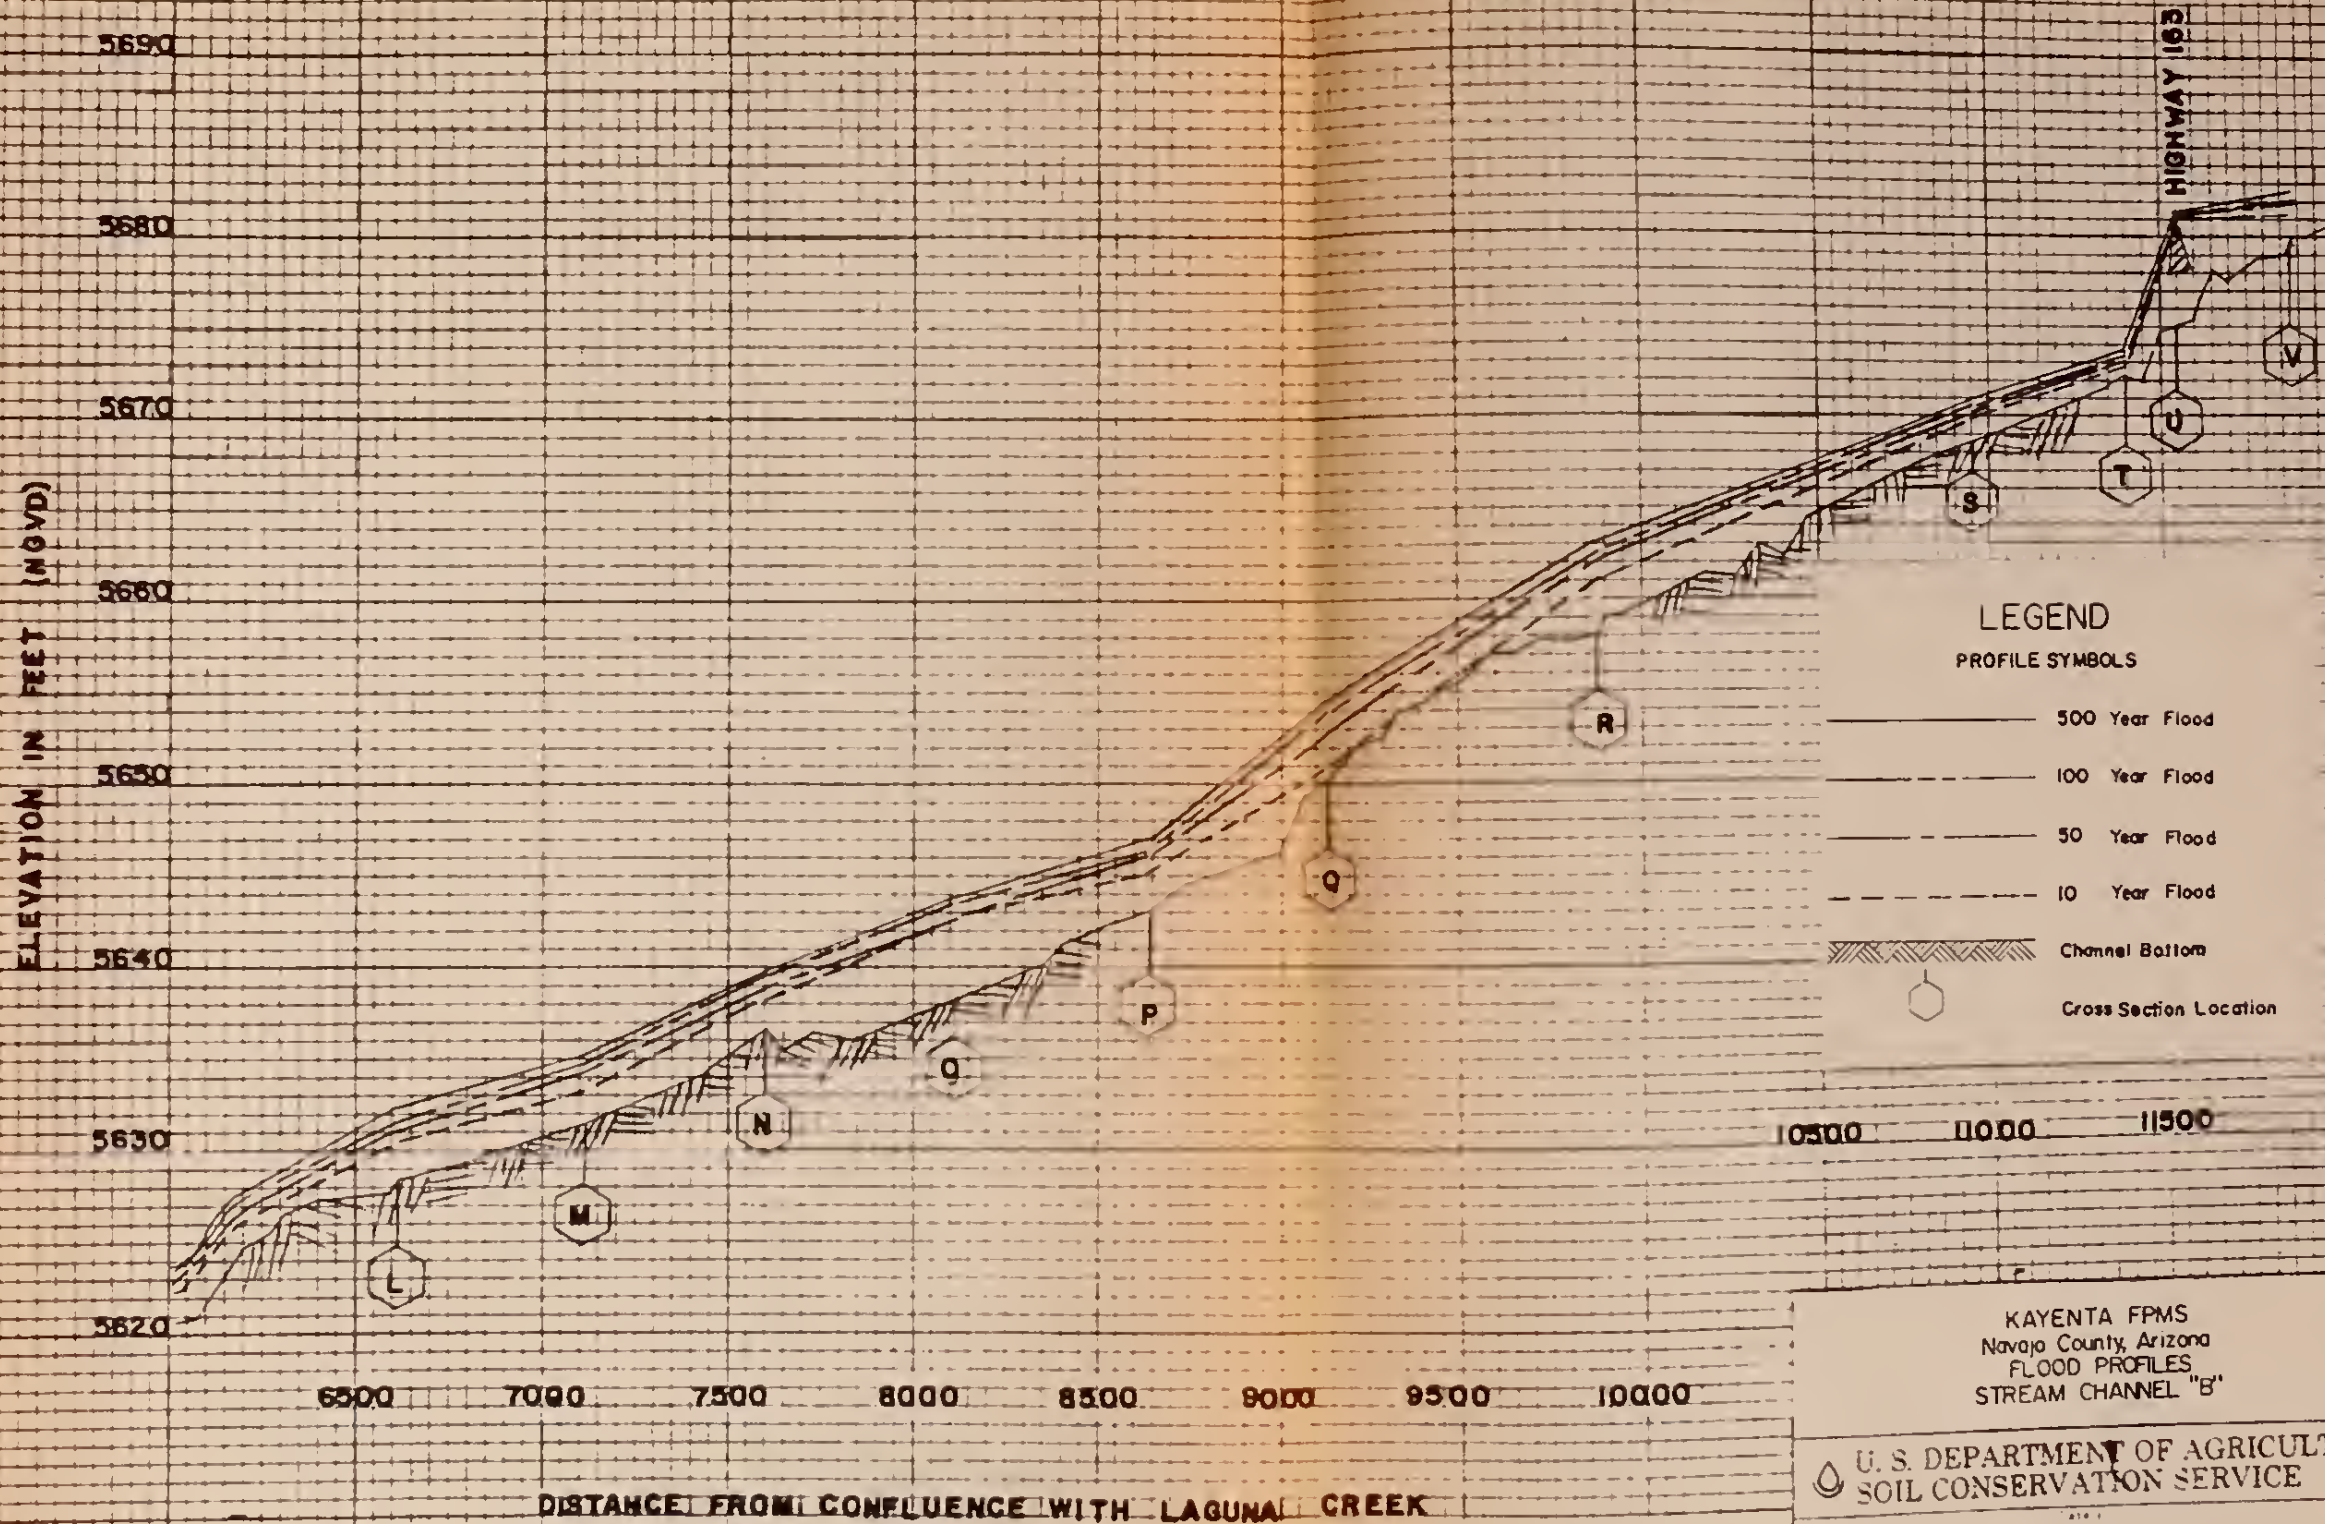
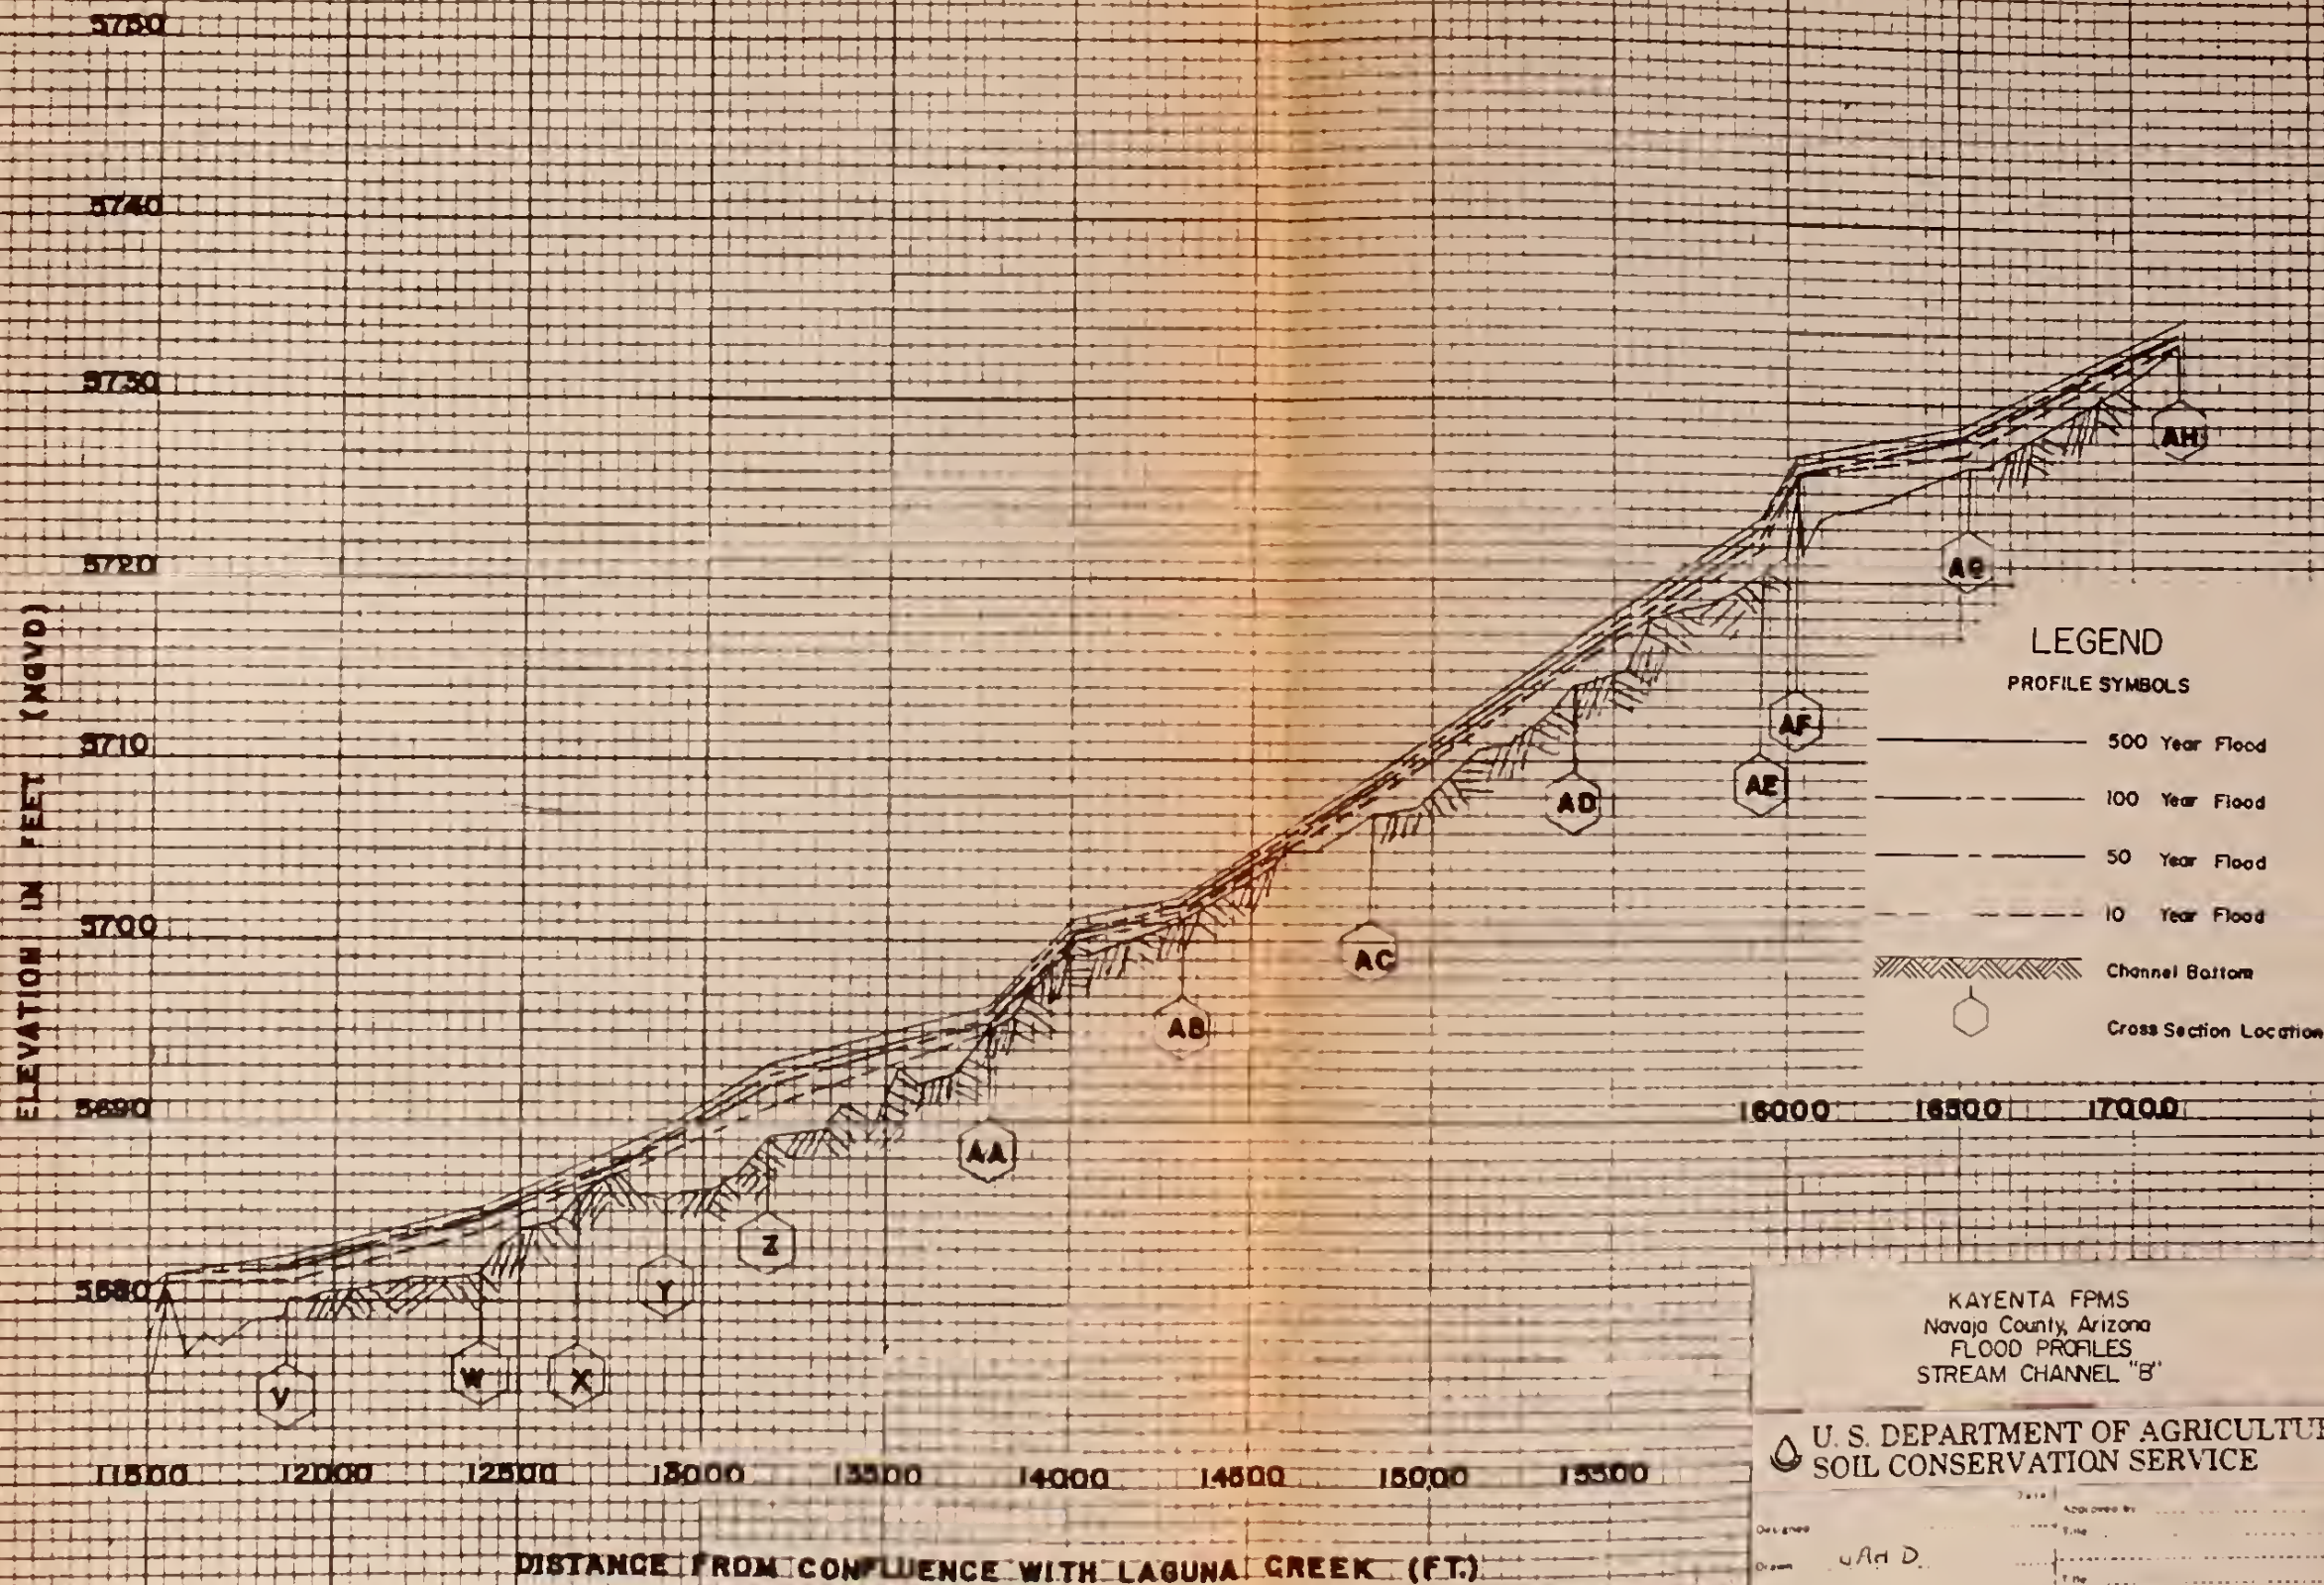
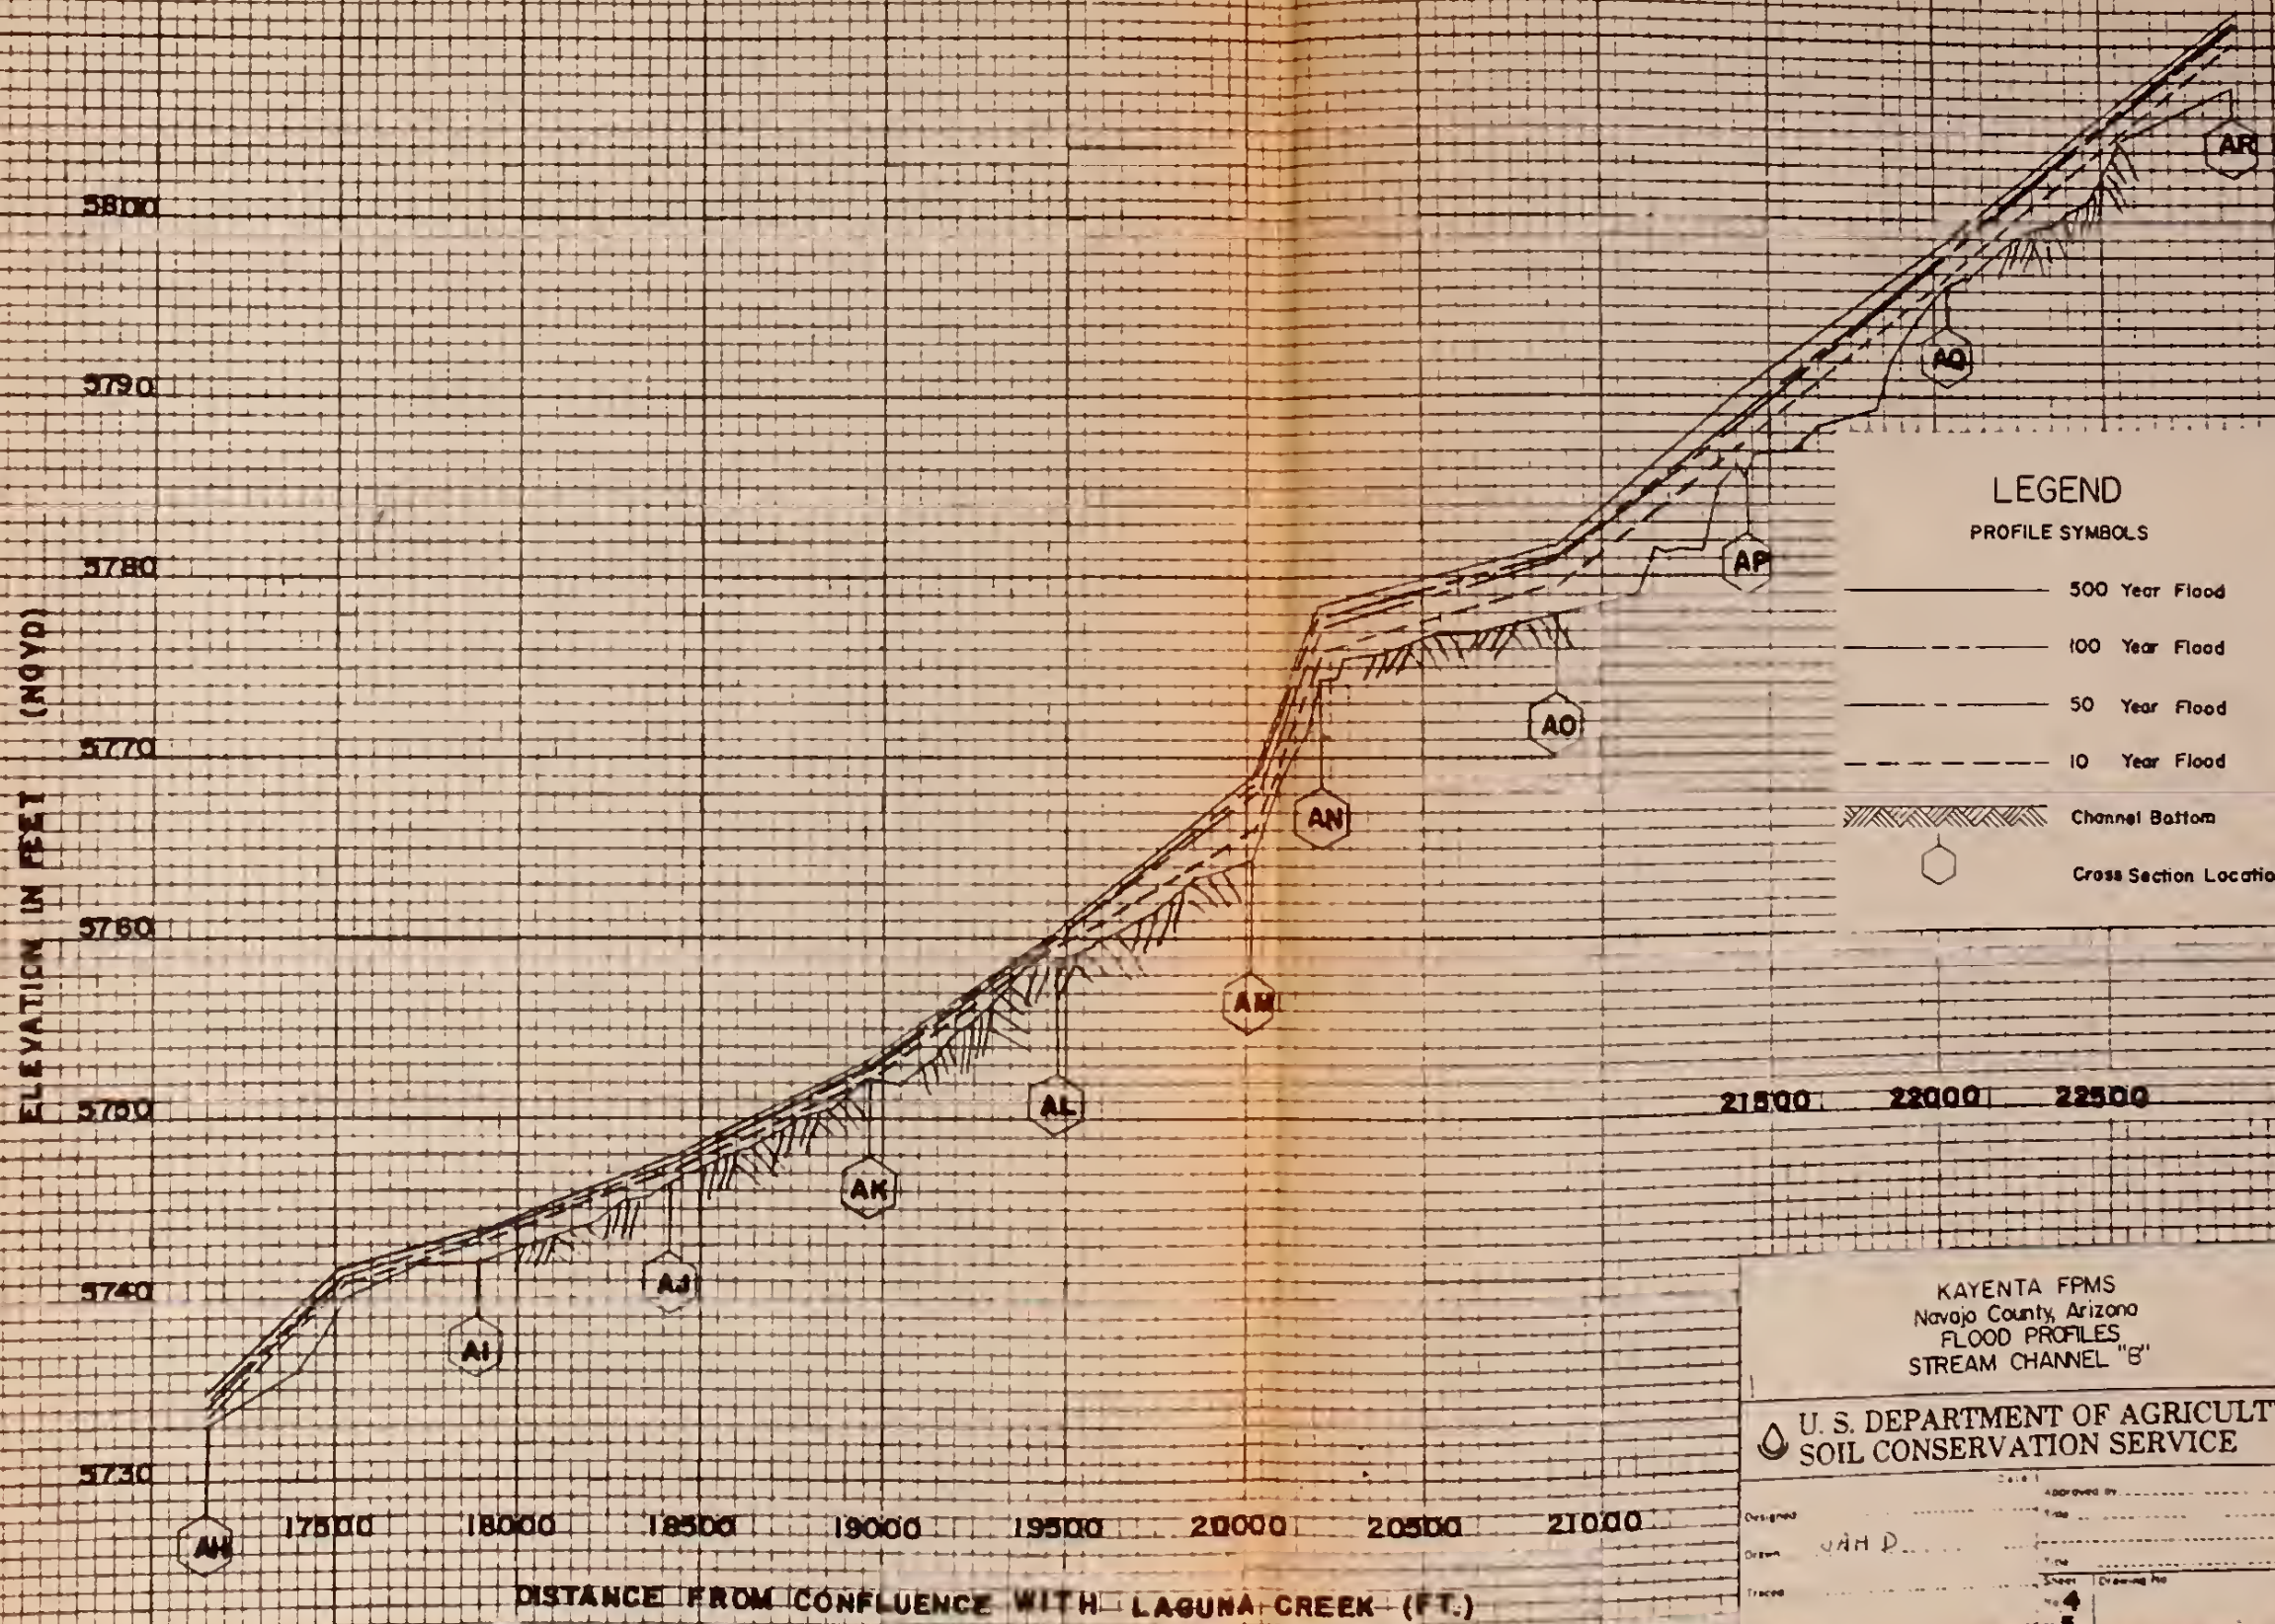
KAYENTA FPMS
 Navajo County, Arizona
 FLOOD PROFILES
 STREAM CHANNEL "B"

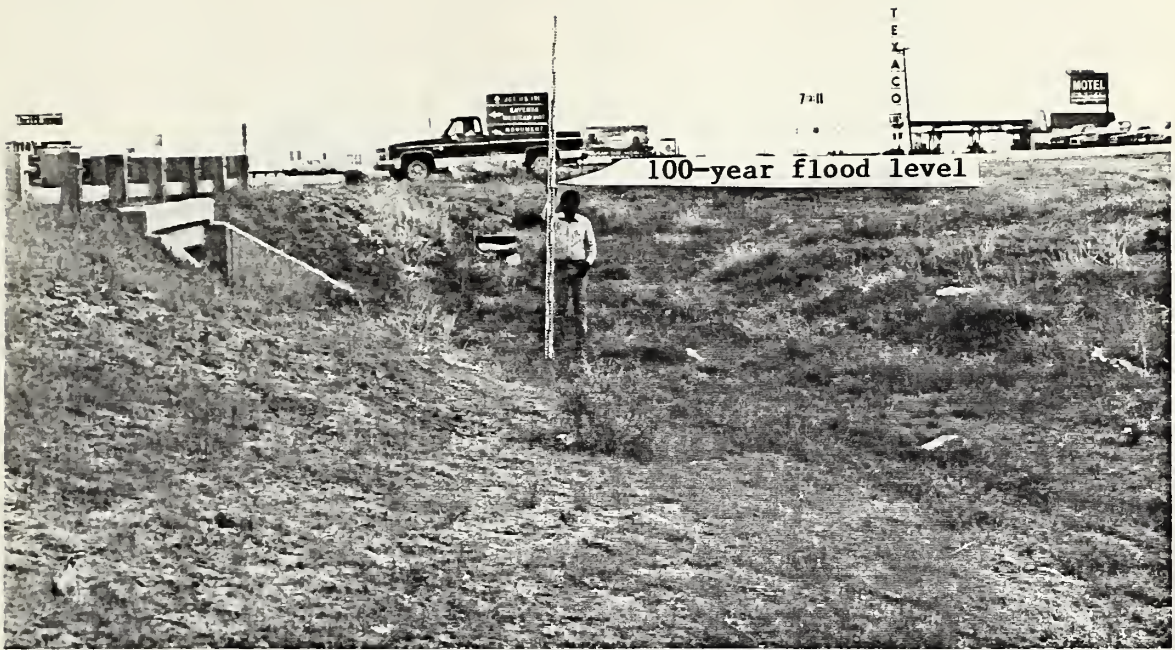
Figure 7
Stream channel "C", at entrance to culvert under Highway 160 near Monument Valley Holiday Inn, near cross section P. Depth, 6.1 ft.

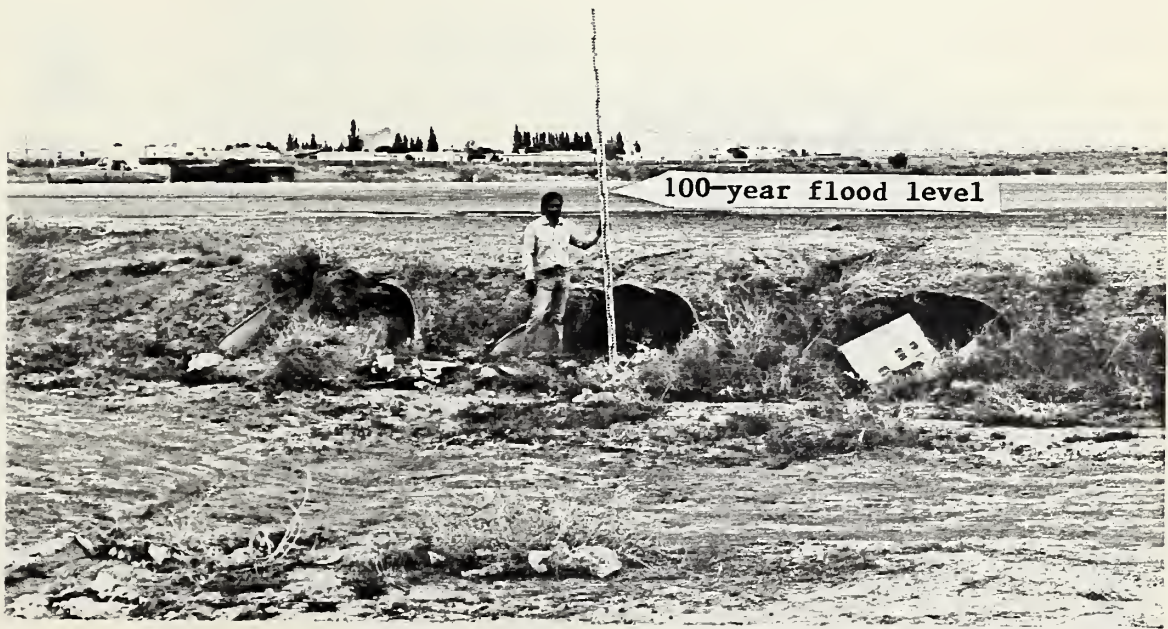
Figure 8
Stream channel "C", at entrance to culverts under Highway 163, north of Highway 160/163 intersection, near cross section N. Depth, 6.1 ft.

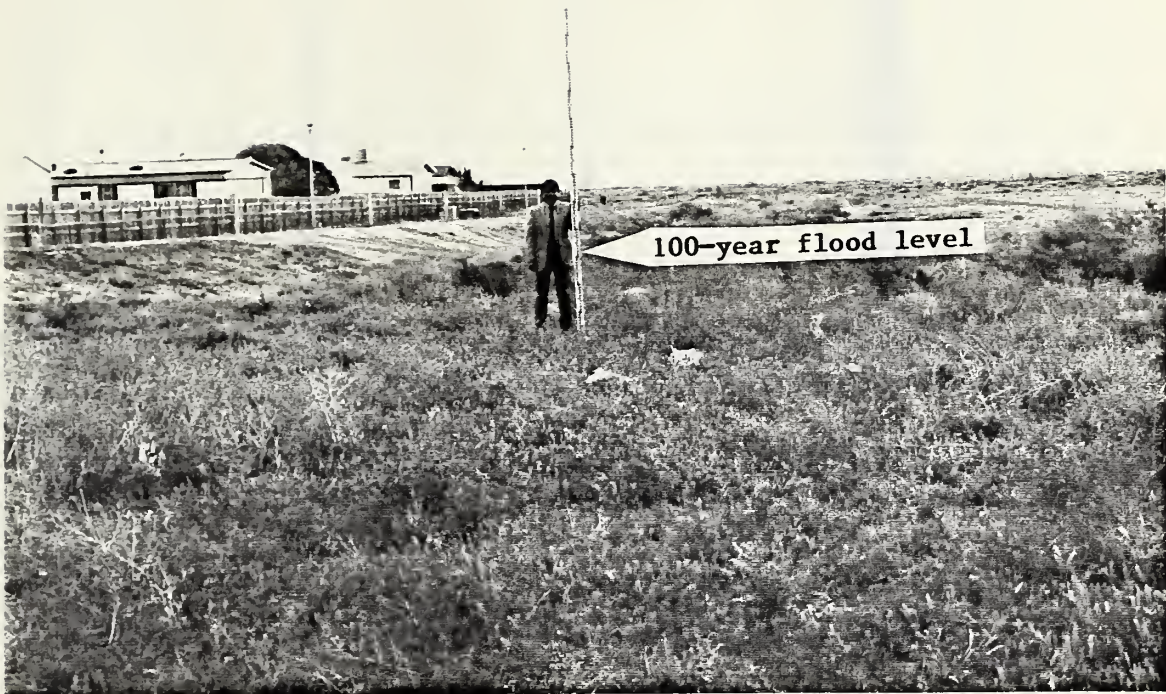
Figure 9

Stream channel "C", along Peabody Trailer Court, near cross section J. Depth, 3.1. ft.

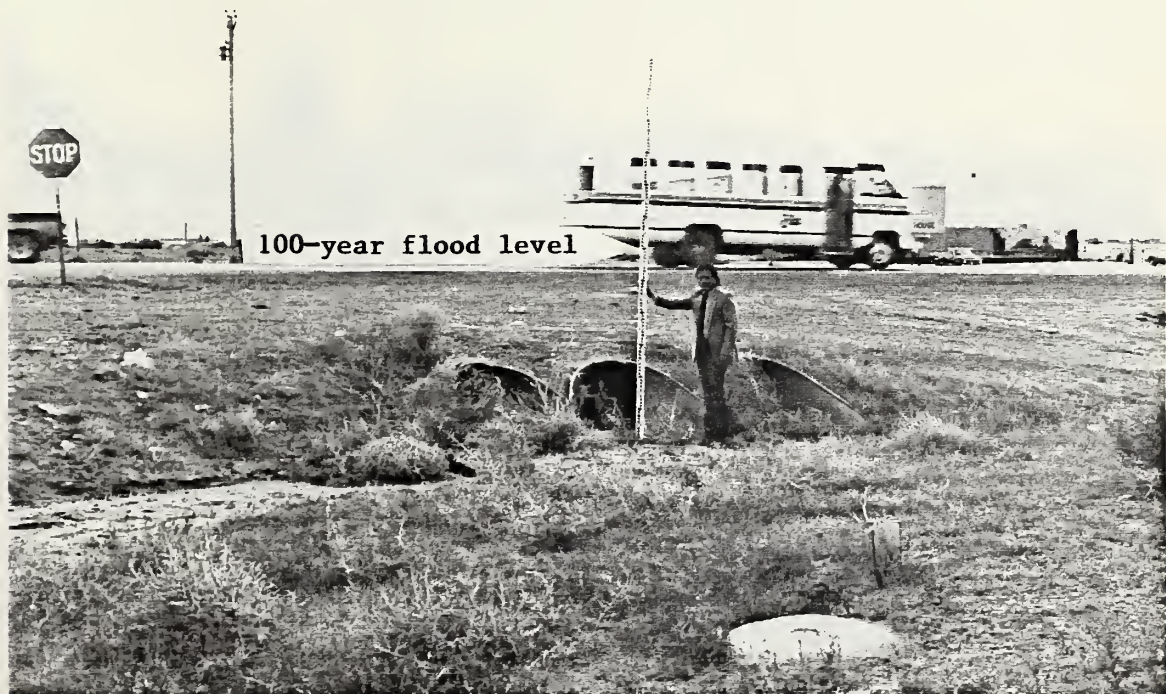
Figure 10

Stream channel "B", at entrance to culverts under Highway 163, near Fieldhouse, vicinity of cross section V. Depth, 6.0 ft.

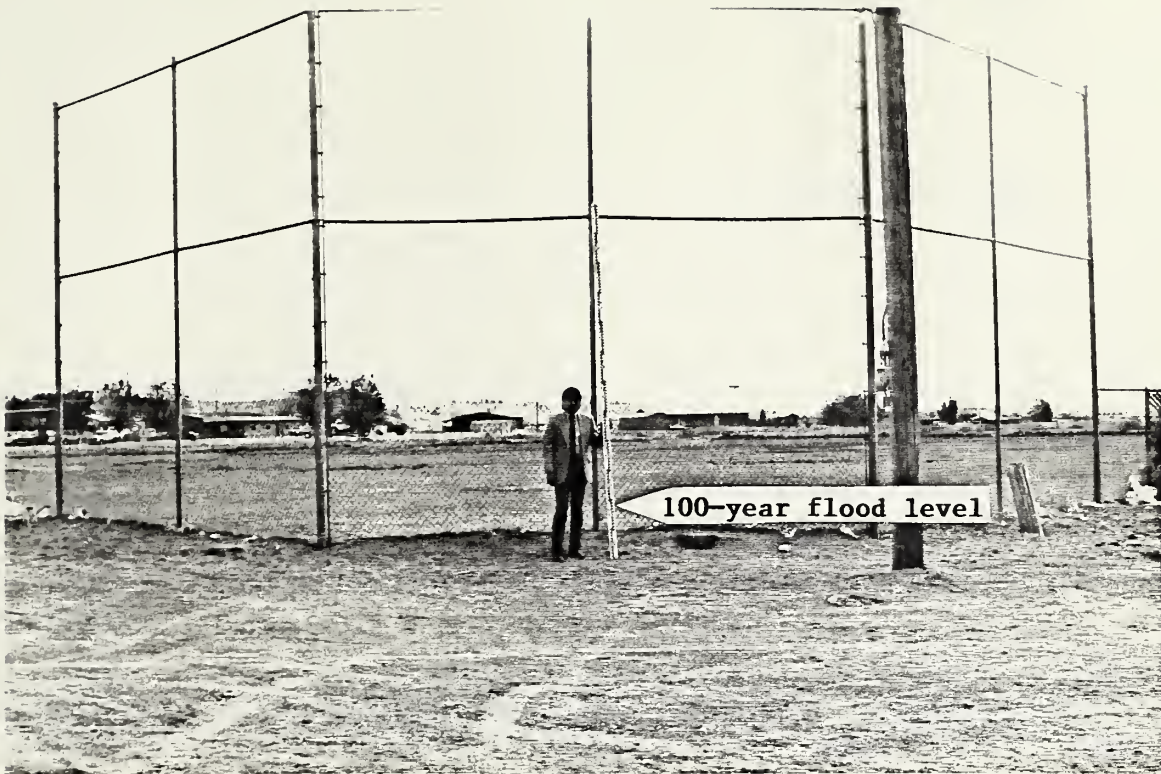
Figure 11
Stream channel "B", at baseball, softball backstop near Fieldhouse, vicinity of cross section S. Depth, 1.7 ft.

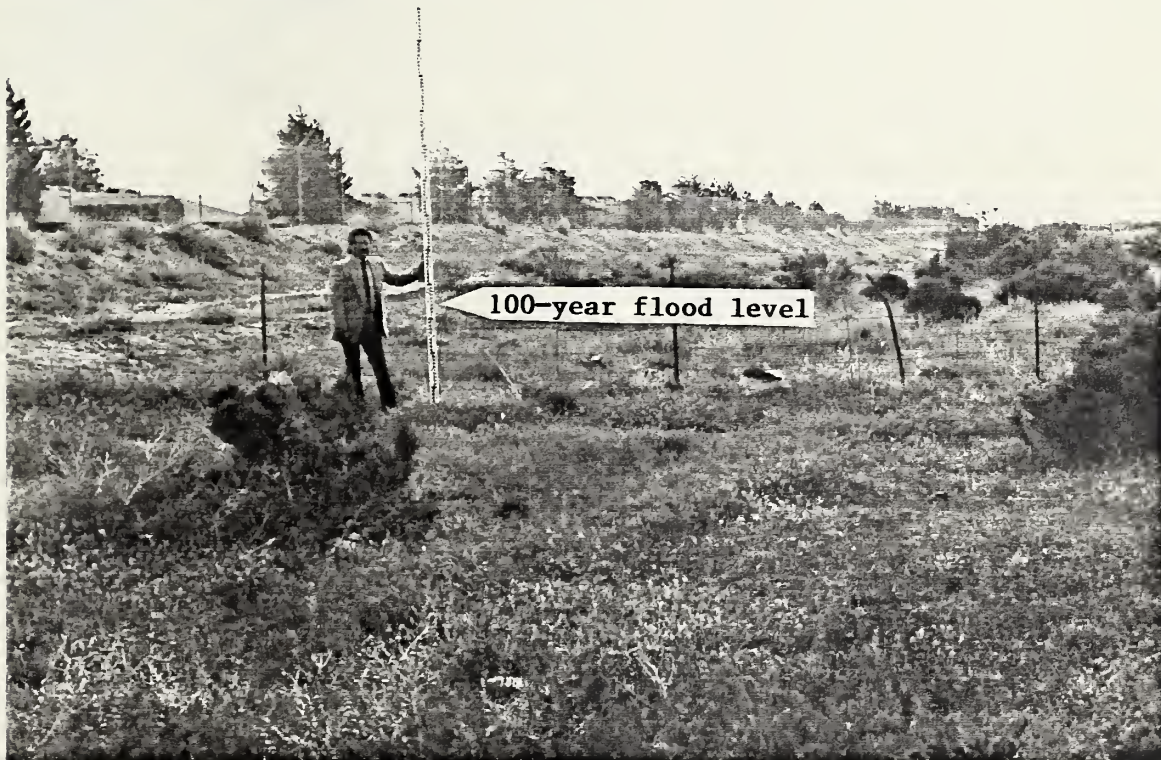
Figure 12
Stream channel "B", near head of dike/channel constructed to protect Kayenta Public School Complex, vicinity of cross section Q, Depth, 3.5 ft.
